| High Tech Computer Corporation Quality Capture Advisory | | | | DOC-00022273 | |
| Issue Date: 2006/10/19 | Revision: A01 | Affected P/N: 76H01398-00M | Description: Excalibur | Effective Date: 2006/10/19 | |
| Reasons: Excalibur Adhesive-Double Tape assembly notice item | | | | | |

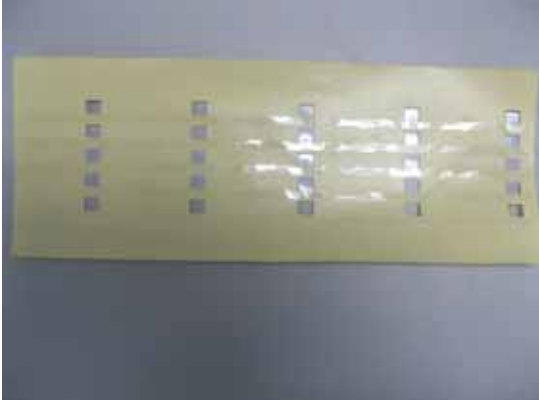
| Fig1. Adhesive-Double Tape (P/N 76H001398-00M) | | | | | |

| Description of Change and Notice: In order to prevent touch sensor floating issue, rework Excalibur jog bar please change Adhesive-Double Tape (P/N 76H001398-00M) | | | | | |

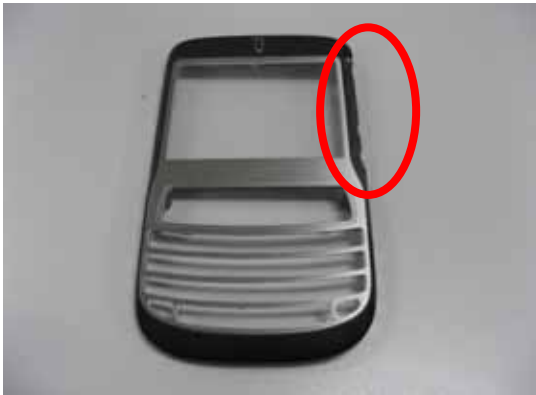
| Fig2. Mylar stick position | | | | | |
